MISCELLANEOUS PAPER SL-81-1

**CONCRETE AND ROCK TESTS
MAJOR REHABILITATION OF DRESDEN ISLAND
LOCK AND DAM, ILLINOIS WATERWAY
CHICAGO DISTRICT, PHASE II COMPLIANCE
SCOUR DETECTION**

R. L. Stowe, B. A. Pavlov

March 1981
Final Report

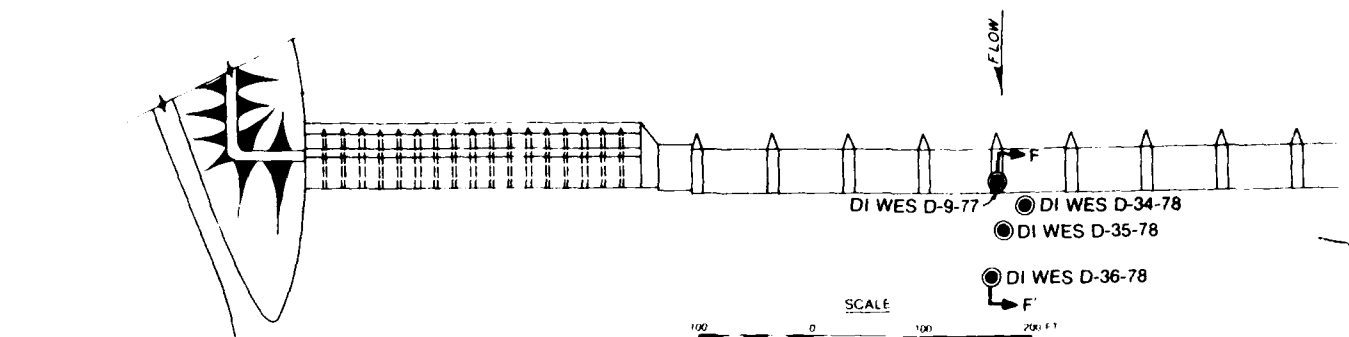
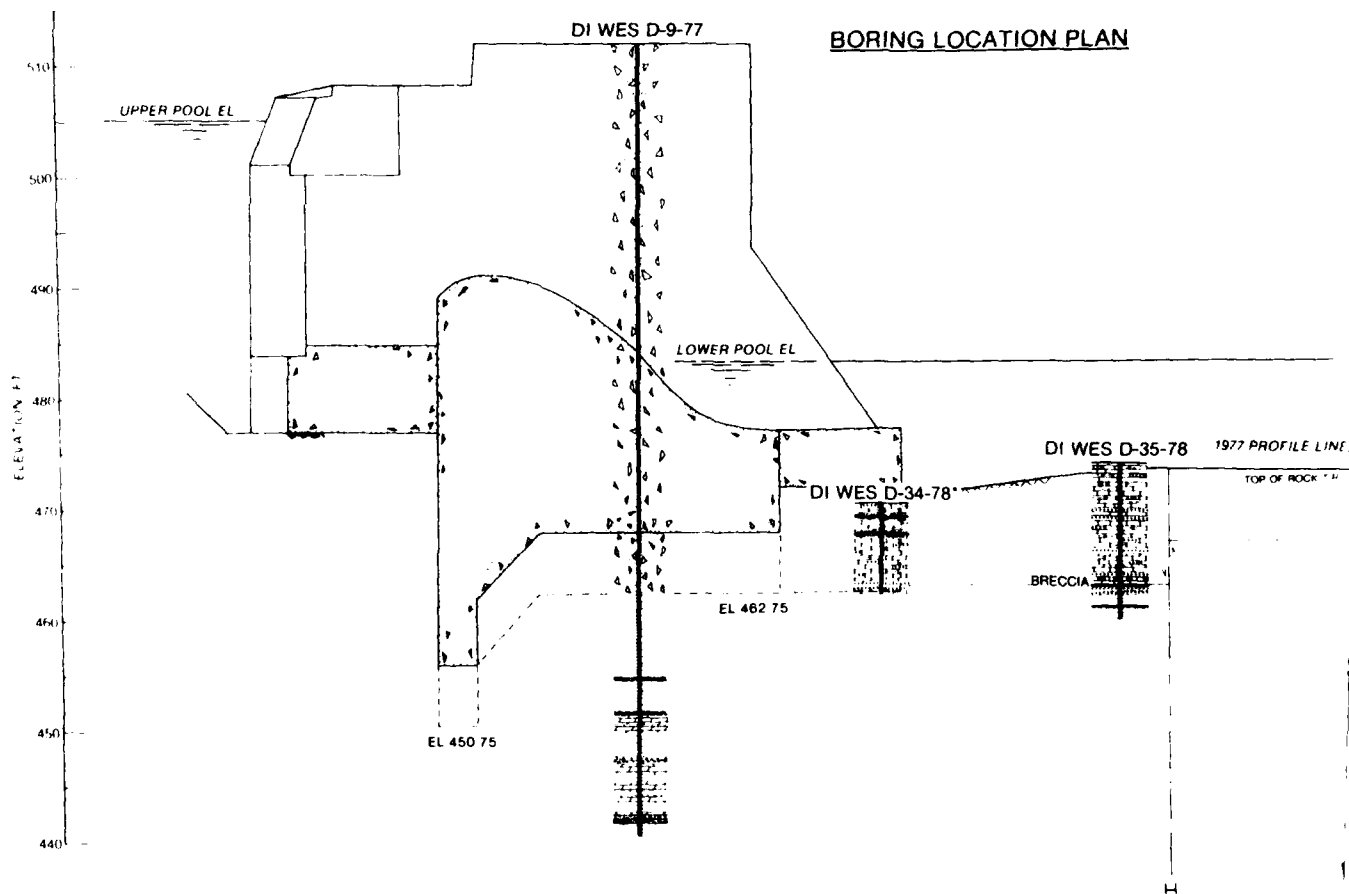
SCOUR DETECTION
DRESDEN ISLAND LOCK AND DAM
ILLINOIS WATERWAY
GEOLOGIC CROSS SECTION
SECTION E-E'

CONCRETE APRON MISSING
AT THIS BORING SITE

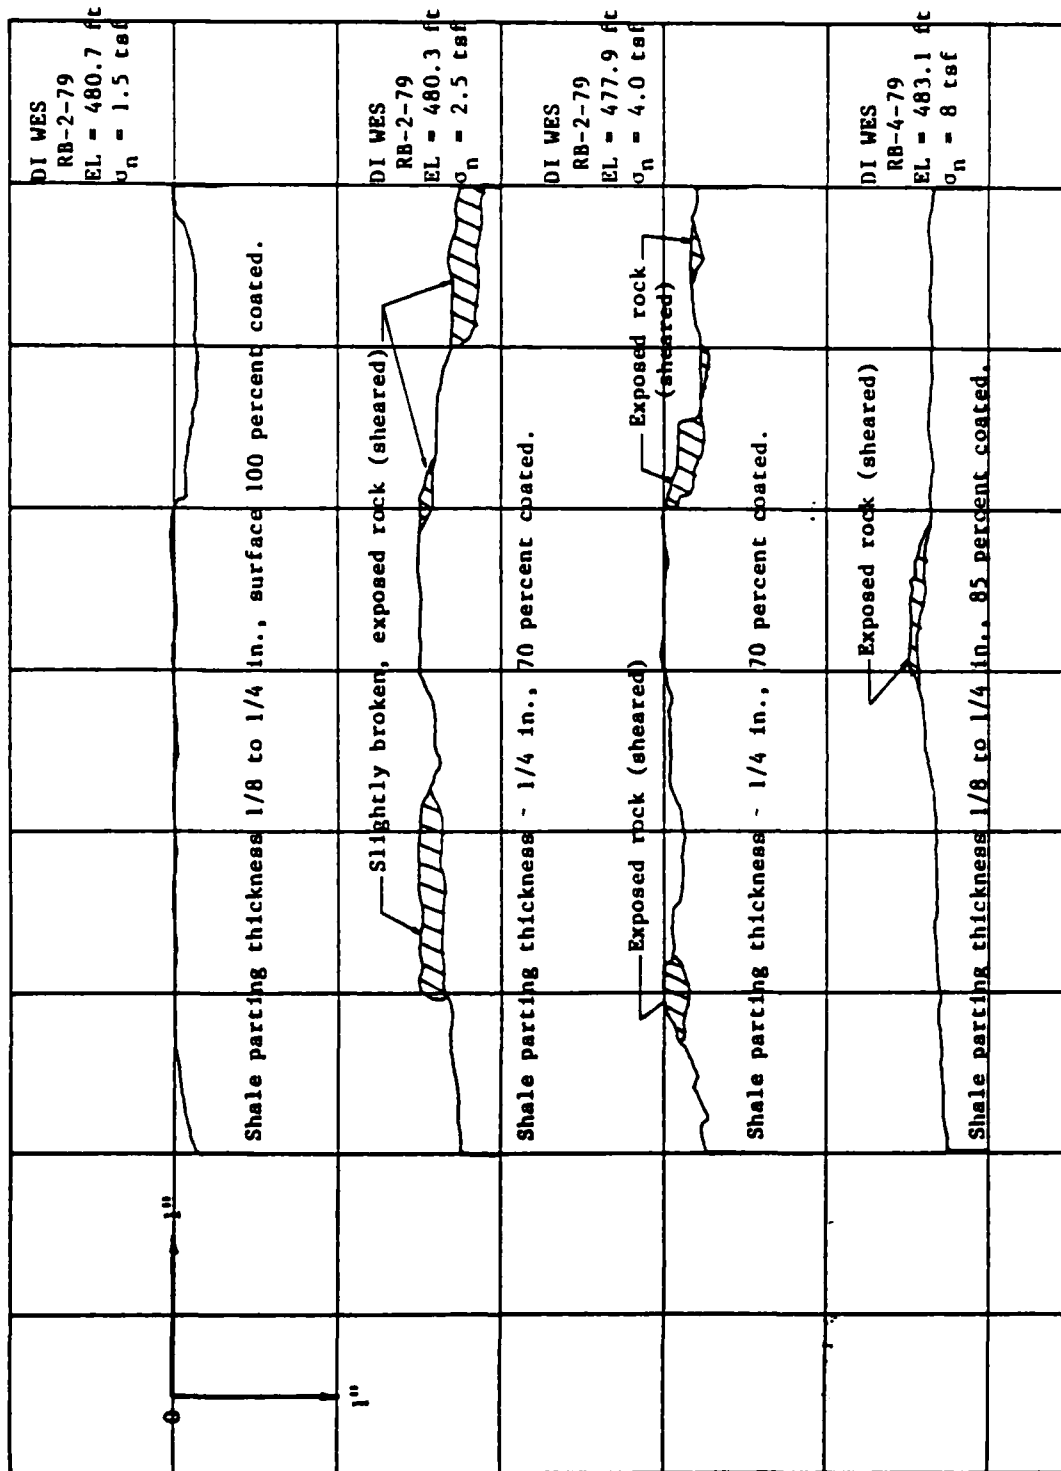
PROFILES OF SPECIMENS AFTER SHEARING, SHALE/CLAY SEAMS IN LIMESTONE
